Tactile Walking Surface Indicators in the United States and Internationally

Research, Standards, Guidance, and Practice

Beezy Bentzen, Janet Barlow--Accessible Design for the Blind
Robert Wall Emerson--Western Michigan University
Bastian Schroeder, Paul Ryus--Kittelson & Associates, Inc.

Published September 2021

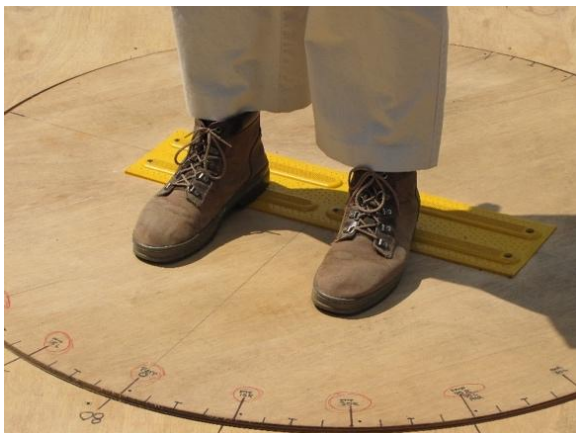
(a) Bars perpendicular to intended travel direction (b) Bars parallel to intended travel direction

Figure 2. Examples of surfaces used for testing by Scott et al. (2011a).

Figure 2 depicts examples of the plywood ramps used for testing alignment based on the six different cues (Scott et al. 2011a). Each cue could be turned so that it was or was not oriented to indicate travel in the same direction as the ramp slope. Figure 2(a) shows a person taking a direction from bars perpendicular to the intended direction of travel. Figure 2(b) shows a person who has taken a direction from bars parallel to the intended direction of travel.

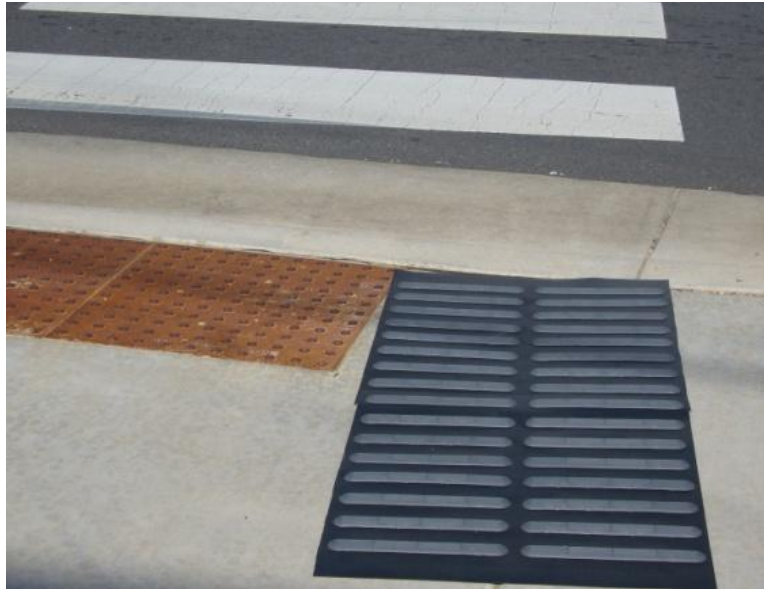
Figure 3. Photo of a guidance surface with raised bars perpendicular to the direction of travel across the crosswalk (Bentzen et al. 2017).

Based on the results of Scott et al. (2011a, 2011b), Bentzen et al. (2017) installed a temporary guidance surface prototype of raised bars at six non-corner crossings. The purpose of this study was to determine whether such a surface could aid wayfinding at crossings where there is otherwise insufficient detection and alignment information for pedestrians who are blind. The surface was installed across the width of the sidewalk and beside the DWS to indicate the location of the crosswalk and to provide a cue for alignment (see Figure 3). The bars of the guidance surface were oriented perpendicular to the direction of travel on the crosswalk. The dimensions and spacing of the bars were the same as in the previous laboratory research (Scott et al. 2011a). When used in other countries to indicate the location of crosswalks, the raised bar guidance surface typically orients the bars parallel to the direction of travel on the crosswalk. Because Bentzen et al. (2017) were interested in identifying a surface that could aid with both crosswalk detection and pedestrian alignment, they oriented the raised bars perpendicular to the direction of travel on crosswalks. This decision was based on prior research in both the U.S. (Scott et al. 2011a, 2011b) and Japan (Takeda et al. 2006) that found that direction-taking from raised bars perpendicular to the intended direction is more accurate than direction-taking from raised bars parallel to the intended direction.

Without the guidance surface, research participants who were blind passed crosswalks without detecting them on 17.9% of trials and aligned in a heading that would have resulted in crossing completion outside of the crosswalk on 47.9% of trials. The prototype guidance surface resulted in reducing passing the crosswalk without detecting it to 2.4% and decreased headings that would have resulted in crossing completion outside the crosswalk to 22.7% (both statistically significant).

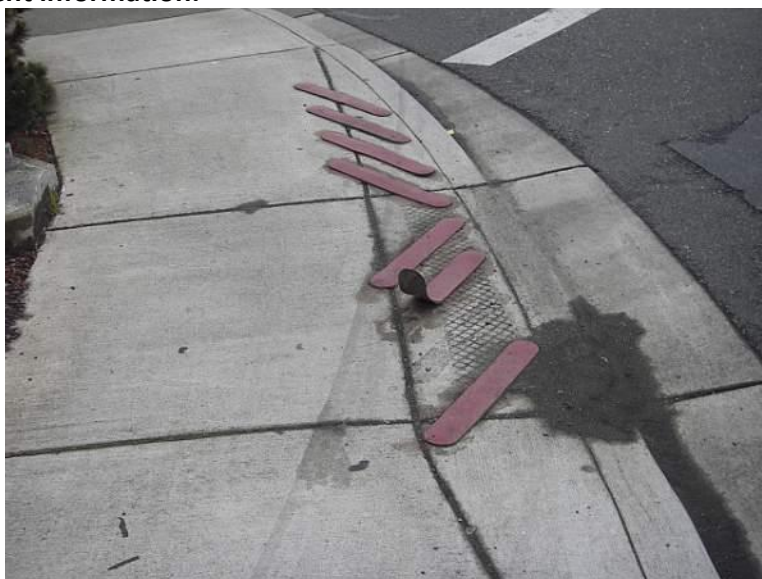
Figure 12. Angled tactile bars installed at an apex curb ramp, at angles perpendicular to the direction of travel on each of the crosswalks served by the curb ramp.

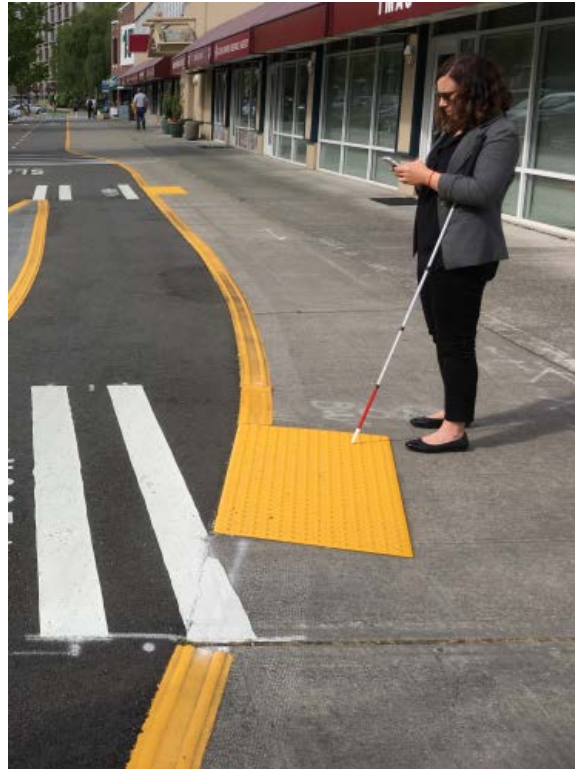
Figure 13. Guidance surfaces delineating bicycle and pedestrian areas and crossings in Seattle, WA.

wide guidance surface comprised of two raised bars used in Seattle to delineate between the pedestrian and cycle areas in a sidewalk-level shared bikeway. A 24-inch (600-mm) deep area of a DWS indicates where pedestrians are intended to cross the bikeway. Figure 14 shows a 12-inch (300-mm) wide delineator strip of methyl methacrylate (MMA) being installed as a central delineator on a shared bicycle lane at sidewalk level in Seattle.

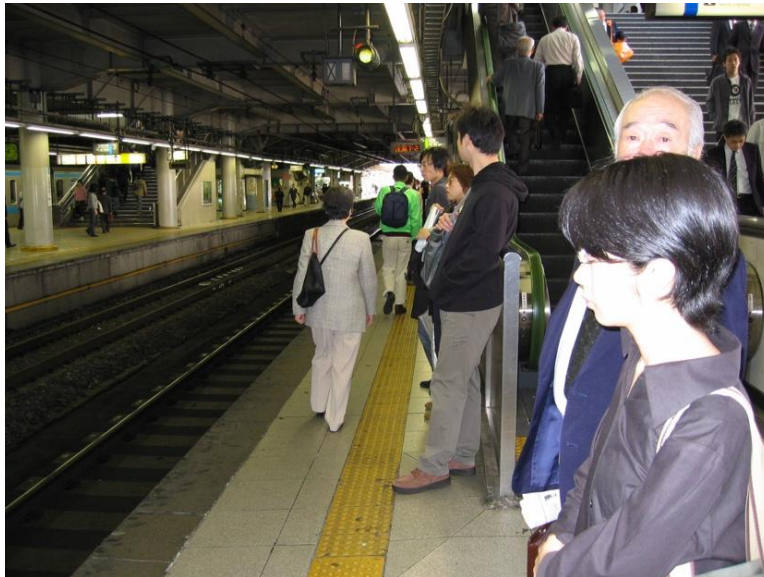
Figure 15. Travelers walking along platform edge, between domes and drop-off.

Both truncated dome attention fields and raised bar guidance surfaces are ubiquitous throughout Japan, but installations vary somewhat in dimension and material composition. Truncated domes are increasingly installed as areas of discrete “buttons,” while raised bars are also seen as paths of discrete parallel bars rather than as pavers with raised bars`. TWSIs are used indoors in some public buildings as well as outdoors. Despite the universal use of TWSIs placed on the full length of high-level train platforms, the frequency of platform-edge falls remains a concern (Akatsuka, Kuskami, and Sato 1999; Fujinami 2005; Okhura et al. 1995; Shimizu et al. 2001; M. Tauchi, personal communication 2008). As a result, additional TWSIs have been added on some platforms, most commonly consisting of a raised bar preceding the domes or a guiding pattern prior to the platform edge. It is common, especially during times of high platform usage, to see travelers standing or walking on the domes/guiding pattern and between the domes/guiding pattern and the platform edge (personal observation, B. Bentzen 2008) (see Figure 15).

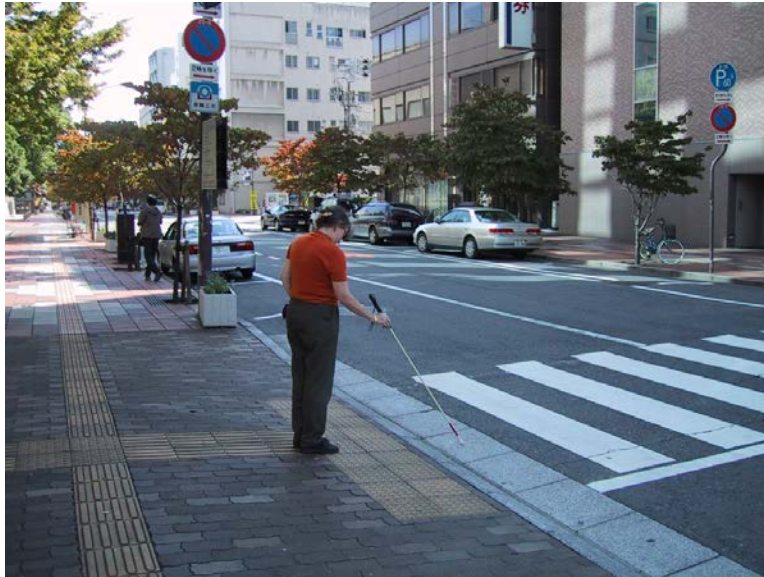
Figure 16. A guidance surface and attention field at a mid-block crossing in Japan.

When guiding patterns are used on sidewalks, they always lead to crossings. At mid-block crossings, guiding patterns extend across the sidewalk, with raised bars oriented parallel to the crossing direction, leading to the attention field preceding the crossing (see Figure 16). At all crossings, there is an area of truncated domes placed at, or a short distance from, the curb line.

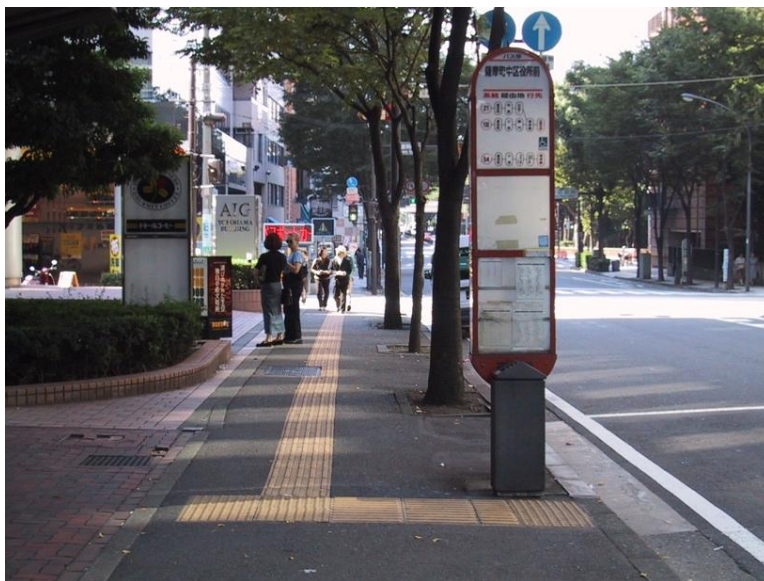
Figure 17. Guidance surfaces and attention fields used to aid in locating a bus stop.

TWSIs are commonly used to indicate the path toward and the location of specific destinations such as bus stops, tactile maps, and elevators, as illustrated in Figure 17.

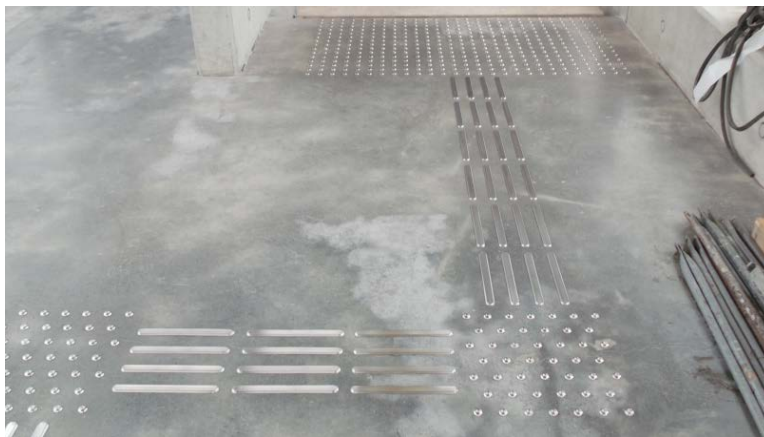
Figure 19. Guidance surfaces and DWS leading to a staircase in Mississauga, Ontario.

staircase in Mississauga, Ontario. The truncated domes and raised bars are discrete elements. Truncated domes indicate turns or decision points, as well as the top of the stairs.

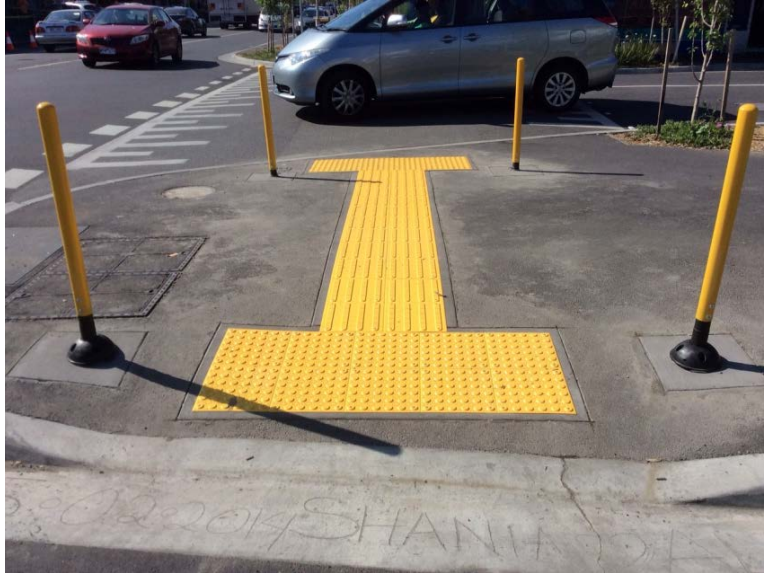
Figure 21. TGSIs across a splitter island in Melbourne, Australia.

TGSIs are widely used throughout Australia. The photos below show examples of installations in public rights-of-way. Figure 20 shows a raised-bar guidance strip across the sidewalk at a roundabout. The guidance strip does not extend down the curb ramp to the truncated cone warning, and the warning surface is at an angle to the curb line so that the edge farthest from the curb line is perpendicular to the crosswalk. Figure 21 shows TGSIs across a cut-through splitter island in Melbourne. Truncated cones aligned with the direction of travel on the associated crosswalk are at each side of the island and connected by a path of raised bars.

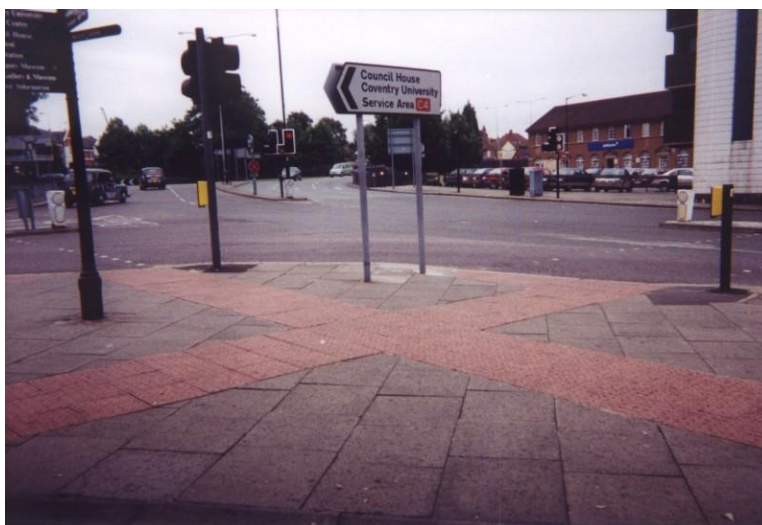
Figure 26. Red blister paving leading to two crossings at a corner.

TWSIs more-or-less complying with *Guidance on the use of Tactile Paving Surfaces* (UK Department of the Environment, Transport and the Regions 1998), such as the blister surface controlled crossings (see Figure 26), have been installed in many locations throughout the U.K. during the last two decades. However, in the last several years, numerous jurisdictions have departed from the guidance, making all blister paving gray and omitting the stem at signalized crossings. The Department for Transport issued *Interim changes to the Guidance on the use of Tactile Paving Surfaces* in 2015, which were intended to simplify the TWSI system and make it more usable. Organizations of and for the blind had not been extensively consulted and quickly filed objections to the *Interim Changes*, causing the interim changes to be dropped (RNIB response to “Interim changes to the Guidance on the use of Tactile Paving Surfaces”, 2015; RNIB – DfT Consultation on Tactile Paving 2015).

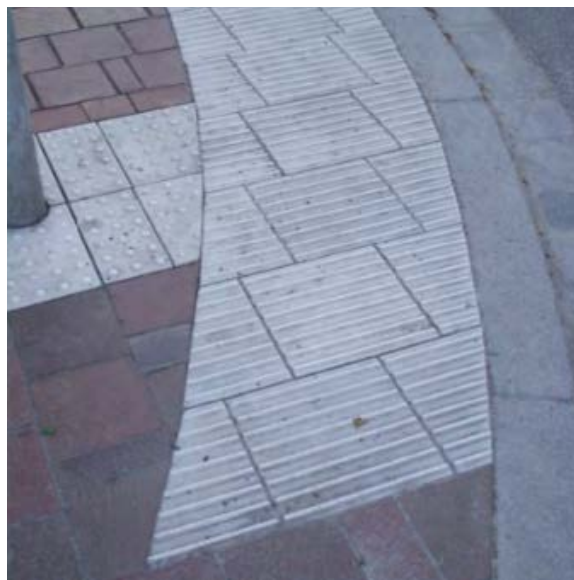
Figure 28. Use of TWSIs to indicate a crossing location.

Sinusoidal wave surfaces are still commonly seen in some locations in Germany, despite their deletion from the standard in 2011. Germany is a federal state, and many states have their own accessibility standards that sometimes differ from the national standard. Therefore, TWSIs vary significantly throughout the country. The city of Bamberg (2014) published a well-illustrated guide to DIN 32984, *Bodenindikatoren im öffentlichen Raum: Leitfaden zur praktischen Anwendung der DIN 32984*. Figure 28 is an illustration from this guide, depicting truncated domes across a sidewalk to indicate the location of a crossing. Raised bars along the curb line are oriented parallel to the crossing direction.
